# Premature failure analysis of a high-strength hot-dip galvanized 42CrMo4 steel bolt

<sup>a</sup>Institute for Materials Testing (IMS), Belgrade, Serbia

This study investigates the premature failure of a high-strength hot-dip galvanized 42CrMo4 steel bolt of property class 10.9 used in a spatial steel structure. The aim was to identify the most likely failure mechanism and provide a basis for preventing similar failures. The investigation included visual and macrographic examination, optical emission spectroscopy, light optical microscopy (LOM), zinc-coating thickness evaluation, and Vickers hardness testing (HV1). The fracture occurred at the head-to-shank junction. The steel exhibited a tempered martensitic microstructure with banding, while the zinc coating was 82-155 µm thick and showed local damage and cracking. Hardness values ranged from 330 to 401 HV1, with several measurements exceeding 350 HV1. All measured alloying elements except carbon were within the nominal composition ranges for 42CrMo4 steel. Considering the fracture morphology, elevated local hardness, coating condition, and short time to failure, hydrogen embrittlement was identified as the most likely failure

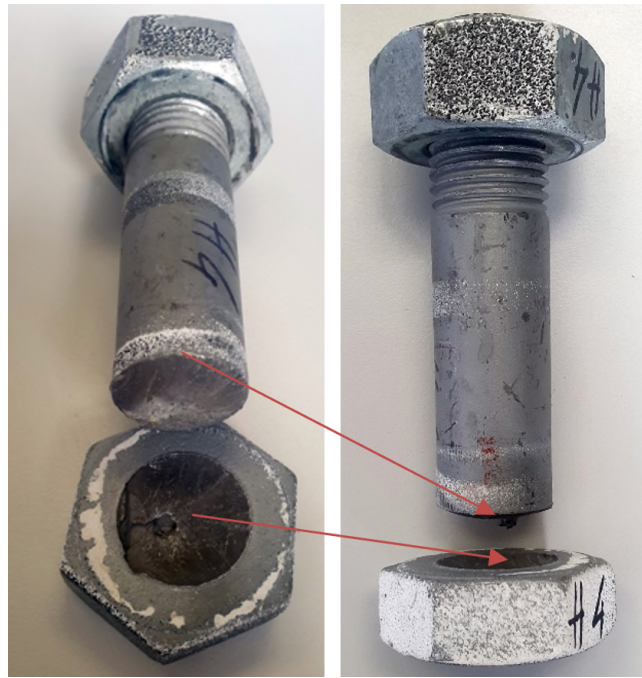
**Fig. 2** Broken bolt that was received for testing

The high-strength hot-dip galvanized 42CrMo4 steel bolt investigated in this study experienced a premature brittle fracture at the critical head-to-shank junction. To determine the underlying cause of the fracture and characterise the material, the investigation included the following stages:

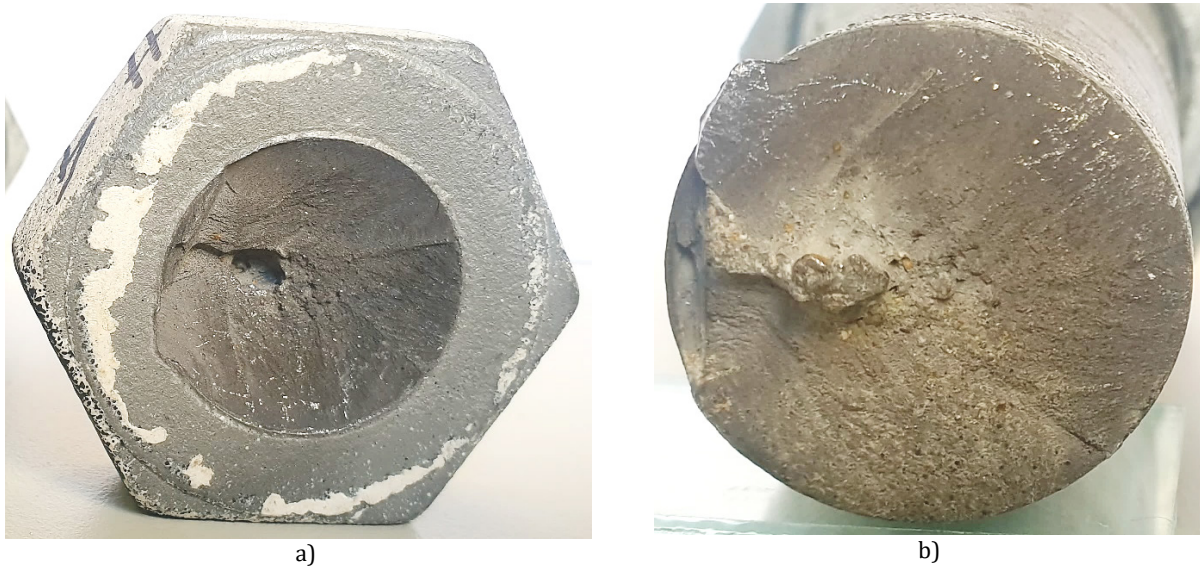
Fig. 3 shows the fracture surface of the bolt on both the head and shank. A cross-section of bolt failure shows two clearly distinct areas: a smooth area along the entire outer edge and a quasi-circular rough region located in the central part of the cross-section of the bolt. The rough, central region of the failure surface has a significantly smaller area compared to the zone of stable crack propagation. The failure is straight, perpendicular to the axis of the bolt, see also Fig. 2.

**Fig. 3** Fracture surfaces on the received bolt: (a) head; (b) shank

According to the client, the high-strength class 10.9 bolt failed a few days after installation. The fracture morphology in Fig. 3 indicates that an initial crack formed at the head-to-shank junction and propagated rapidly to final failure. Considering the short time to failure, the high-strength 42CrMo4 steel, and the sequence of heat treatment and hot-dip galvanizing, hydrogen embrittlement (HE) is the most likely failure mechanism [17, 18]. Because the bolt was installed in a statically loaded structure for only a short period, fatigue is unlikely to have been the dominant failure mechanism.

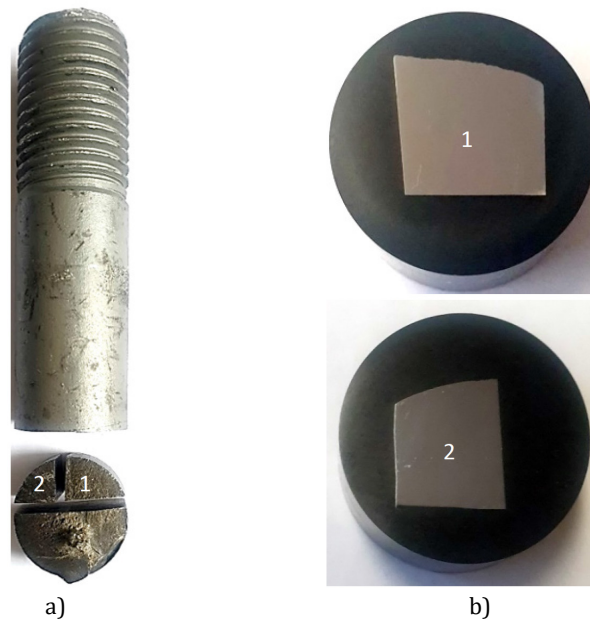
Fig. 4 shows a sectioned part of the bolt shank with the fracture surface and the mounted metallographic samples marked 1 and 2. The preparation procedure for samples 1 and 2 included grinding, mechanical polishing, and etching with 3 % nital.

**Fig. 4** Sampling for microscopic analysis: (a) cutting a part of the bolt shank with a fracture surface; (b) mounted metallographic samples 1 and 2

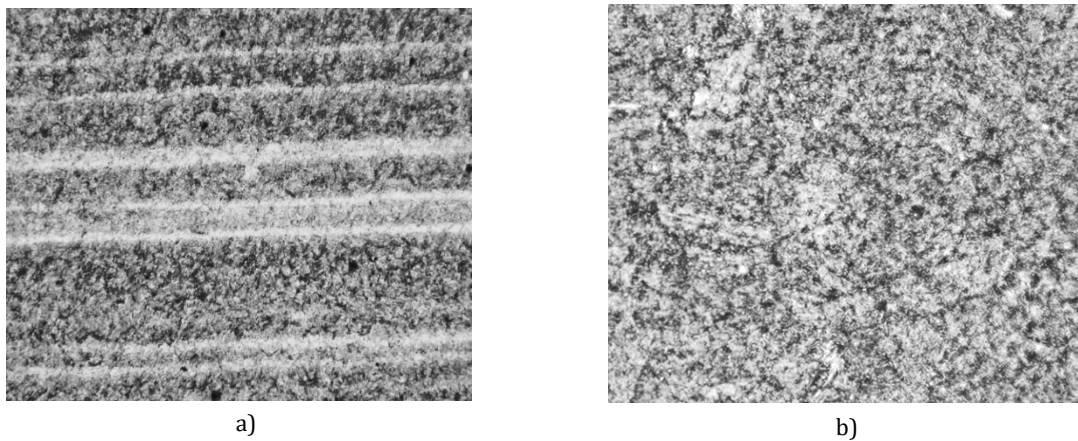
Metallographic analysis of the cross-section of the fracture surface was carried out using an optical microscope at magnifications of 100× and 500×. The microstructures of samples 1 and 2 were similar, showing banding parallel to the longitudinal axis of the bolt (Fig. 5a) and tempered martensite (Fig. 5b).

**Fig. 5** Photographs of the cross-section of the fracture surface of tested samples 1 and 2: (a) banded microstructure (magnification 100×); (b) tempered martensite (magnification 500×)

Apart from carbon, which was measured below the nominal range, the chemical composition of the tested steel was within the prescribed values for grade 42CrMo4. The bolt was quenched and tempered, and its microstructure consists of tempered martensite. Banding parallel to the bolt axis was also observed; however, it was not considered the primary cause of the fracture.

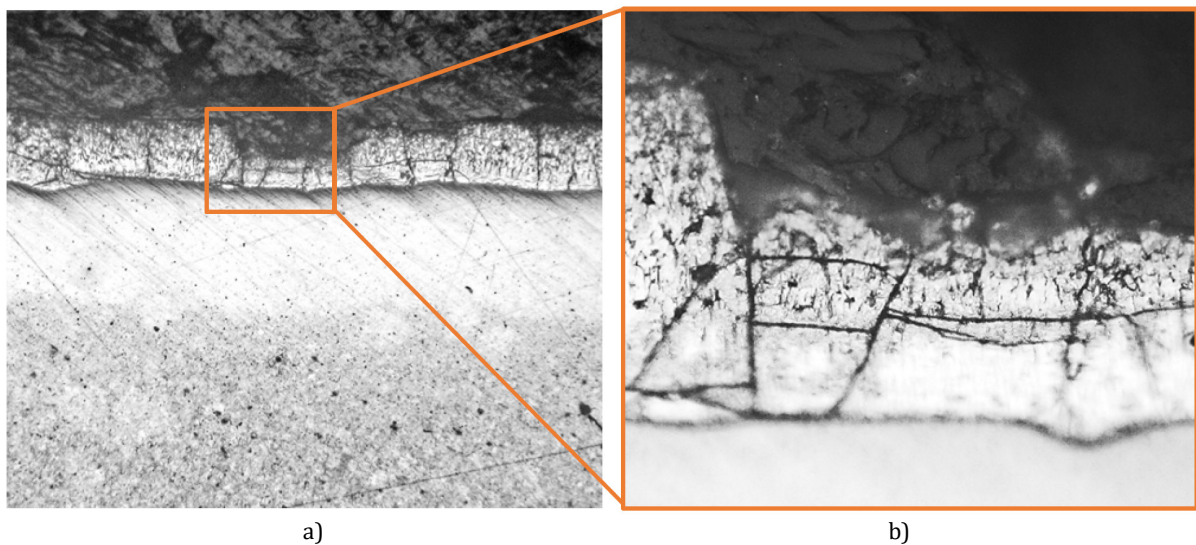
Based on microstructural examination using a measuring reticle, the thickness of the hot-dip galvanized layer was determined to be 82-155 µm. For reference, EN ISO 10684 specifies a minimum local coating thickness of 40 µm and a minimum batch-average coating thickness of 50 µm [15]. The galvanized layer was partially damaged (Fig. 6a), and cracks were also observed in the coating (Fig. 6b).

**Fig. 6** Photographs of the cross-section of the zinc layer: (a) damage to the zinc layer (magnification 100×); (b) cracks in the galvanized coating (magnification 500×)

The measured coating thickness of 82–155  $\mu\text{m}$  is above the minimum local coating thickness specified in EN ISO 10684 [15]. However, coating thickness alone does not establish galvanizing immersion time or hydrogen uptake; therefore, its role in the present failure cannot be determined from the available data. Cracks and microcracks in the hot-dip galvanized layer may act as local stress concentrators. In the presence of hydrogen and sustained tensile stress, such defects may contribute to susceptibility to hydrogen-assisted brittle fracture [19, 20].

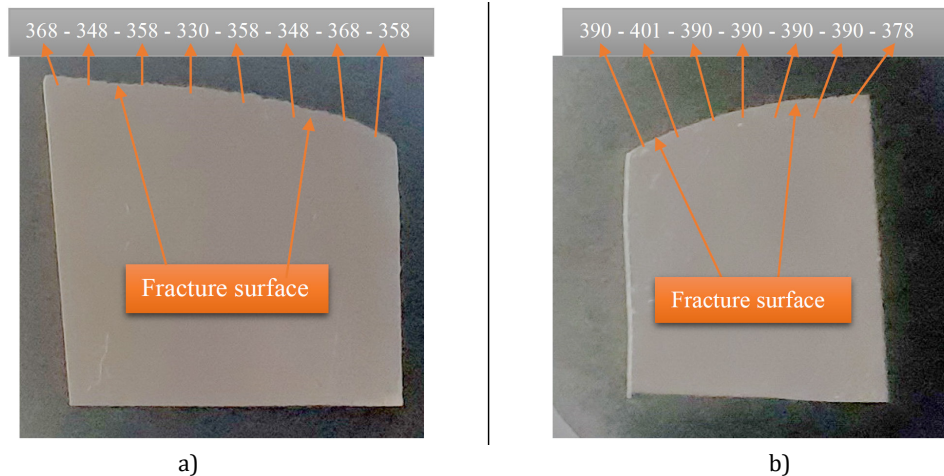
Vickers hardness testing [16] was performed on mounted metallographic samples in the fracture zone, i.e., below the fracture surface. A semi-automatic HENRI HAUSER-BIENE 249a optical hardness tester was used with a test force of 9.807 N (HV1). Fig. 7 shows the locations of the measuring points and the measured hardness values on mounted metallographic samples 1 and 2 (see Fig. 4).

**Fig. 7** Location of measurement points and measured hardness values (HV1) on mounted metallographic samples 1 and 2: (a) sample 1; (b) sample 2

Several subsurface hardness values exceeded 350 HV1, with a maximum measured value of 401 HV1 (Fig. 7). Such elevated hardness increases the susceptibility of high-strength steel to hydrogen embrittlement [4]. General guidance also identifies susceptible high-strength material, hydrogen, and sustained mechanical stress as the key conditions for hydrogen embrittlement [21]. The elevated subsurface hardness therefore indicates increased susceptibility to hydrogen embrittlement, consistent with the findings of Zafra *et al.* [22] for quenched and tempered 42CrMo4 steel. Similar delayed-failure behaviour in high-strength hot-dip galvanized bolts was reported by Artola and Aldazabal [23]. Due to equipment and sample-access limitations, high-resolution scanning electron microscopy (SEM) fractography and direct hydrogen measurement could not be performed in this study. This is an important limitation; nevertheless, the combined evidence of elevated subsurface hardness, optical metallography, coating damage, and the short time-to-failure supports hydrogen embrittlement as the most likely mechanism. Future investigations should incorporate SEM characterisation and direct hydrogen measurement to further detail the fracture micromechanisms.
